Manhole Inspection Summary

Manhole # S57I__026MH

Insp Date: **7/2/08 10:22 AM**

Location Address: **601 s grundy**

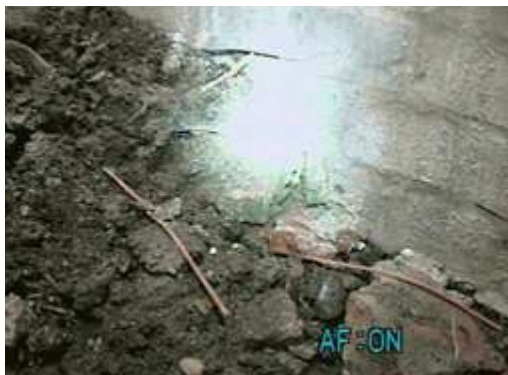
Defect 3

Condition: ☐ Sound ☐ Cracked ☐ Root Intrusion ☐ Deteriorated ☐ Leaks ☒ **Debris**

bench debris

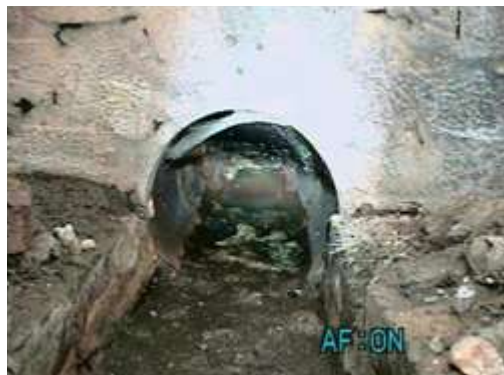
Defect 4

Condition: ☐ Sound ☐ Cracked ☐ Root Intrusion ☐ Deteriorated ☐ Leaks ☒ **Debris**

Channel Debris

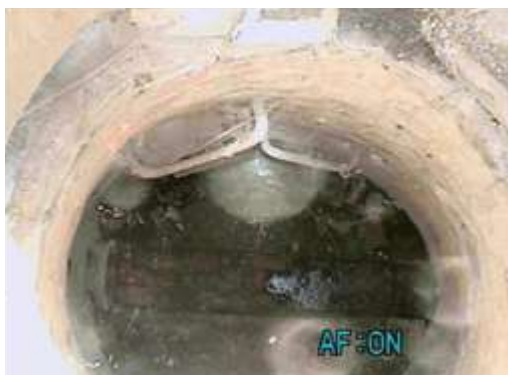
Defect 2

Steps Count: **2** Missing: **0** ☒ **Corroded**

steps

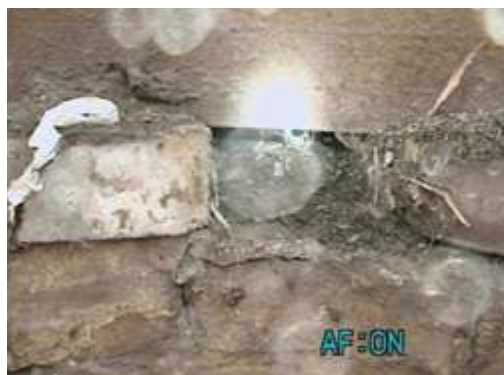
Defect 1

Condition: ☐ Sound ☒ **Cracked** ☒ **Root Intrusion** ☒ **Loose Brick** ☒ **Deteriorated**

chimney loose bricks,
cracked,deteriorated,
frame adj

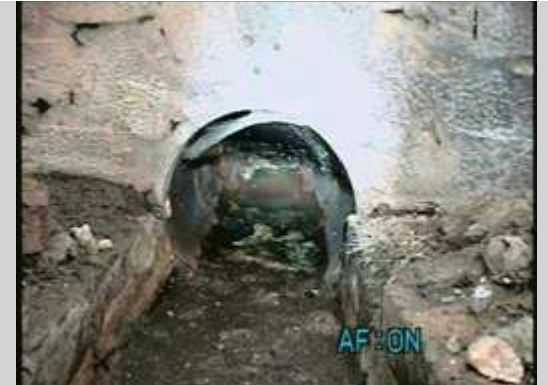
12 O'Clock Outflow

8 in. Circular Gravity Sewer
Pipe Out @ 12 O'Clock

Invert Depth: **5.82** (ft.) Flow Characteristics: **None**

Infiltration: **None** Pipe Seal Cond: **Unknown**

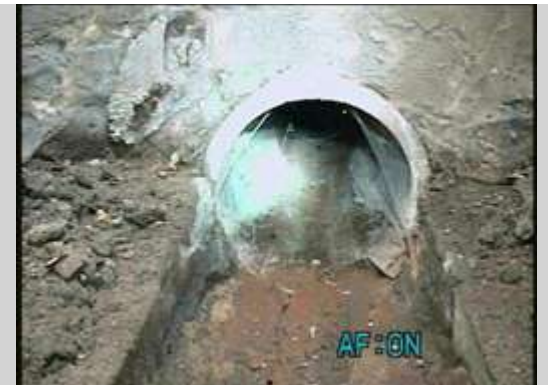
6 O'Clock Inflow

8 in. Circular Gravity Sewer
Pipe In @ 6 O'Clock

Invert Depth: **5.72** (ft.) Flow Characteristics: **None**

Infiltration: **None** Pipe Seal Cond: **Unknown**
